Manhole Inspection Summary

Manhole # S21QQ_009MH

Insp Date: **7/10/07 10:33 AM**

Location Address: **2328 AUCHENTOROLY-WOODBROOK** Cross Street: **WHITTIER AVE**

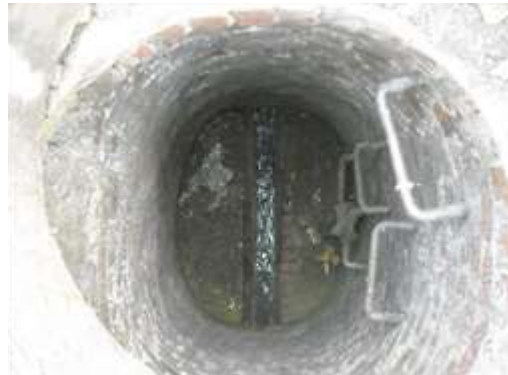
Top View

Steps Count: **5** Missing: **0** ☒ **Corroded**

Surcharge ☒ **Evidence Of Surcharge** Depth: **1** (ft.) ☐ Active Surcharge Present

CORRODED STEPS AND EVIDENCE
SURCHARGE

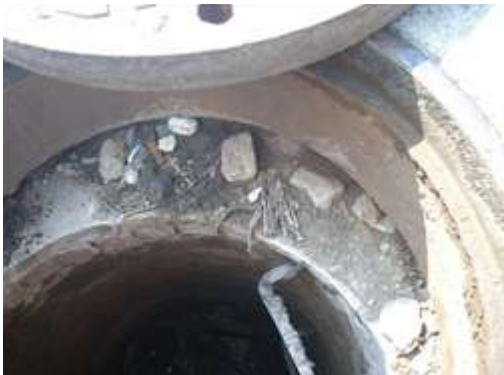
Defect 3

Bench ☒ Exists Material: **Brick** ☐ Parged
Condition: ☒ Sound ☐ Cracked ☐ Root Intrusion ☐ Deteriorated ☐ Leaks ☐ Debris

DEBRIS ON BENCH

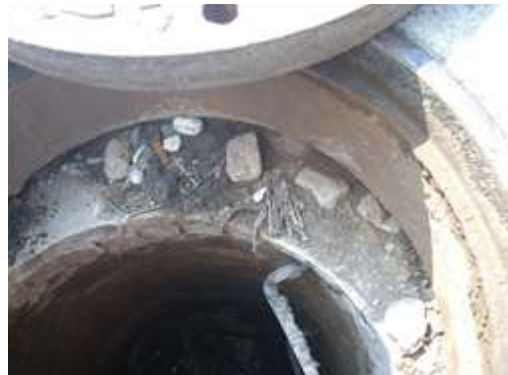
Defect 2

Chimney / Frame Adjustment ☒ Exists Material: **Brick and Concrete** ☐ Parged Height: **4** (in.)
Condition: ☐ Sound ☐ Cracked ☐ Root Intrusion ☒ **Loose Brick** ☐ Deteriorated
Infiltration: ☒ None ☐ Joint ☐ Cracks ☐ Mortar ☐ Roots ☐ Wall

LOOSE BRICKS OF FRAME
ADJUSTMENT

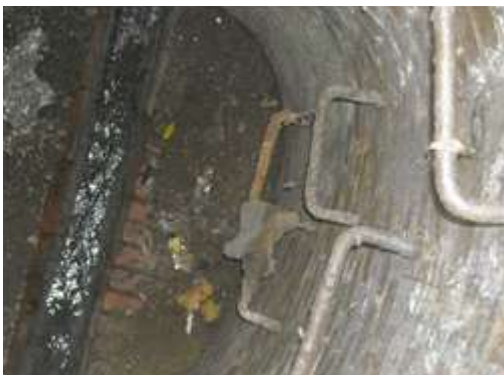
Defect 1

Frame Offset: **4** (in.) Condition: ☒ Sound ☐ Cracked ☐ Leaks

OFFSET FRAME

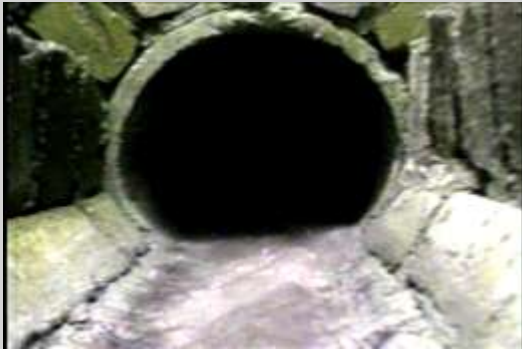
12 O'Clock Outflow

8 in. Circular Gravity Sewer
Pipe Out @ 12 O'Clock

Pipe Height: **8.4** (in.) Rod and Bar (Angled)
Pipe Material: **Clay** ☐ Pipe Lined
Invert Depth: **9.20** (ft.) Flow Characteristics: **Slow**
Deposits: ☐ None ☐ Mud ☐ Sludge ☒ **Debris** ☐ Grease
Silt Depth: **7** (in.) Deposits Extent: **Heavy**
Infiltration: **None** Pipe Seal Cond: **Sound**

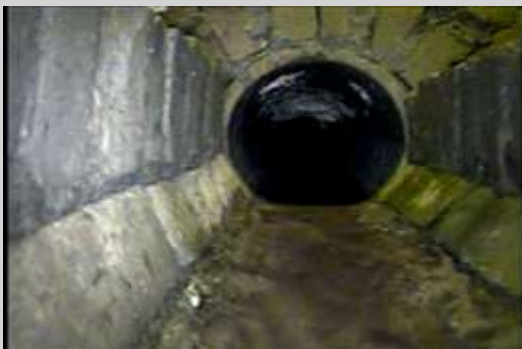
6 O'Clock Inflow

8 in. Circular Gravity Sewer
Pipe In @ 6 O'Clock

Pipe Height: **7.2** (in.) Rod and Bar (Angled)
Pipe Material: **Clay** ☐ Pipe Lined
Invert Depth: **9.04** (ft.) Flow Characteristics: **Slow**
Deposits: ☐ None ☐ Mud ☐ Sludge ☒ **Debris** ☐ Grease
Silt Depth: **8** (in.) Deposits Extent: **Heavy**
Infiltration: **None** Pipe Seal Cond: **Sound**
